## Wood Structural Panel Buckling: Causes and Resolution

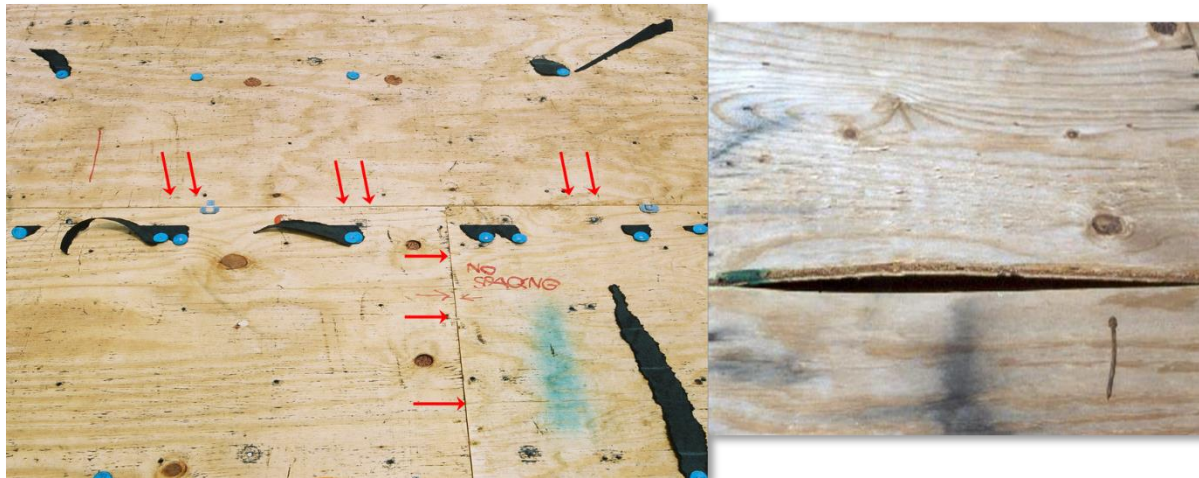
**Figure 1.**

Field investigations involving buckled, warped and/or twisted panels typically reveal that the recommended gap was not provided (see Figure 1). These investigations also often indicate that the size and spacing of the fasteners used to attach the panels to the framing did not conform with manufacturer and building code requirements.

Buckling of the plywood between supports due to wetting on the top surface and inadequate panel spacing during installation.

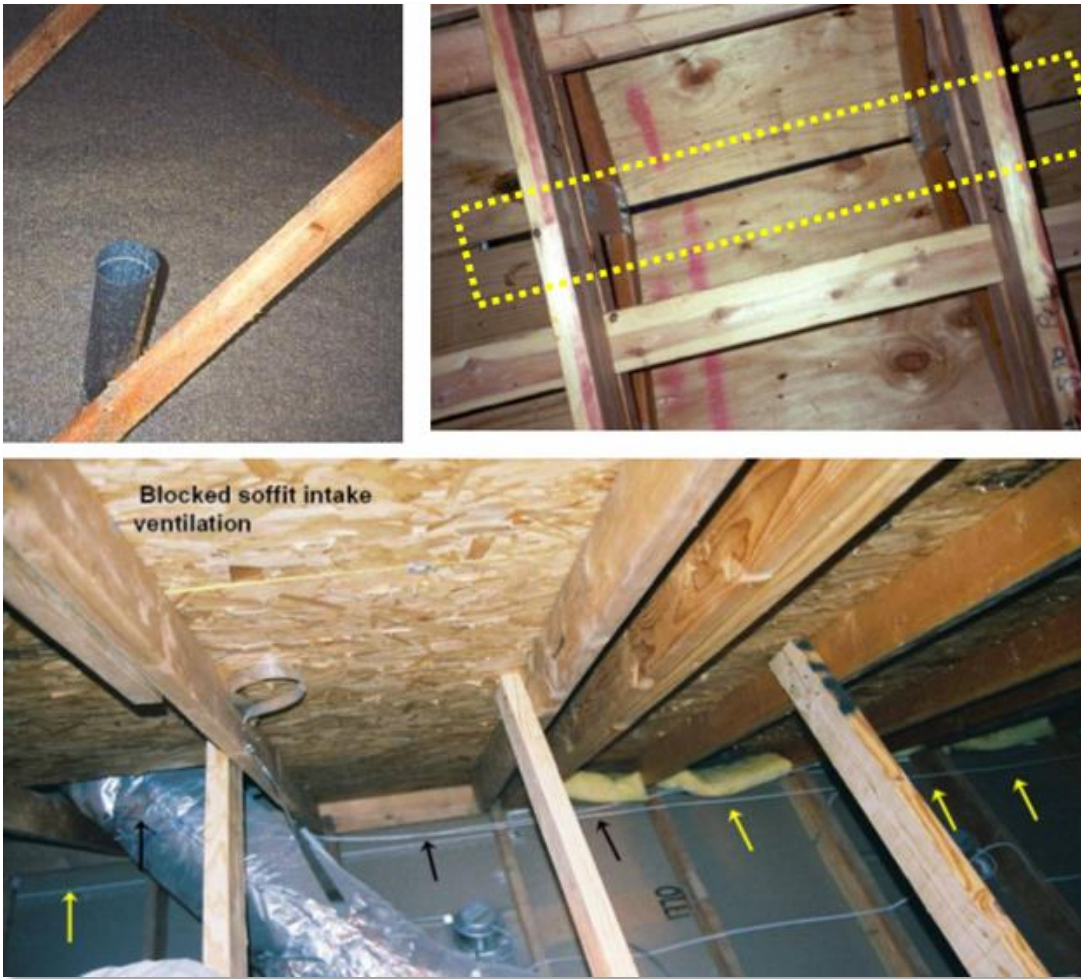
**Figure 2.**

Poor building practices are unfortunately all too common, and include obstruction of soffit and roof ridge vents or the discharge of ventilation ducts from the interior of the building directly into the attic space (see Figure 2). The result of each of these poor practices is an increased moisture load in the attic space, which creates a moisture gradient within the panels and uneven panel expansion. If the panels are not spaced and/or fastened properly and are exposed to

Top left: Ventilation duct from interior of building terminates in attic space instead of directly to outside of the building.

Top right: Space in panels for continuous ridge vent has been covered by roofing underlayment and shingles.

Bottom: Soffit intake ventilation has been covered by insulation and lumber blocking.

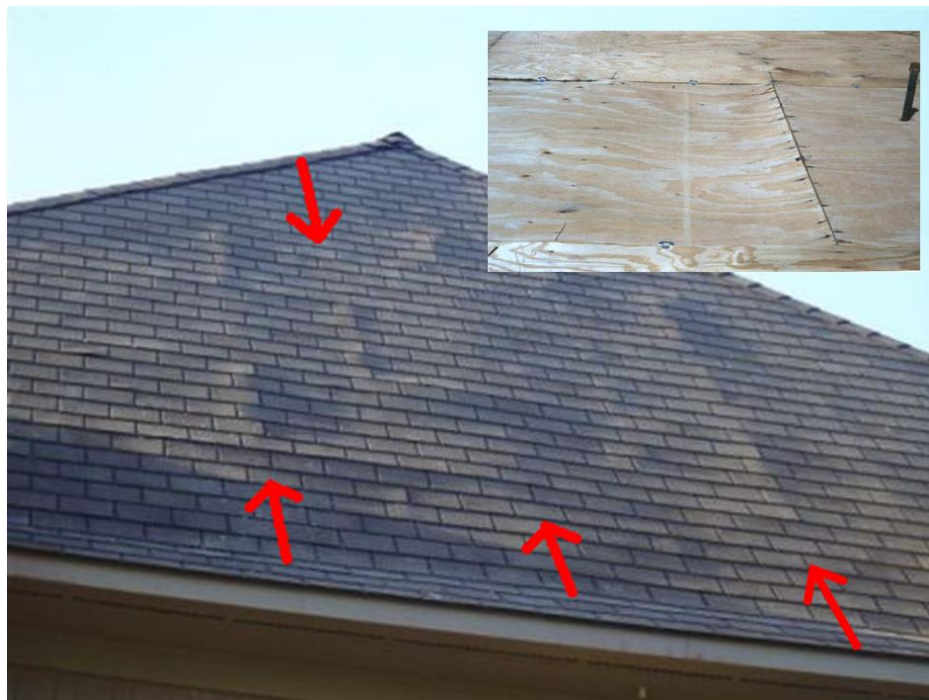
excessive moisture from any of these examples, buckling or warping is usually the result (see Figure 3).

**Figure 3.**  
Buckling and ridging of the roof sheathing panels due to ventilation problems.

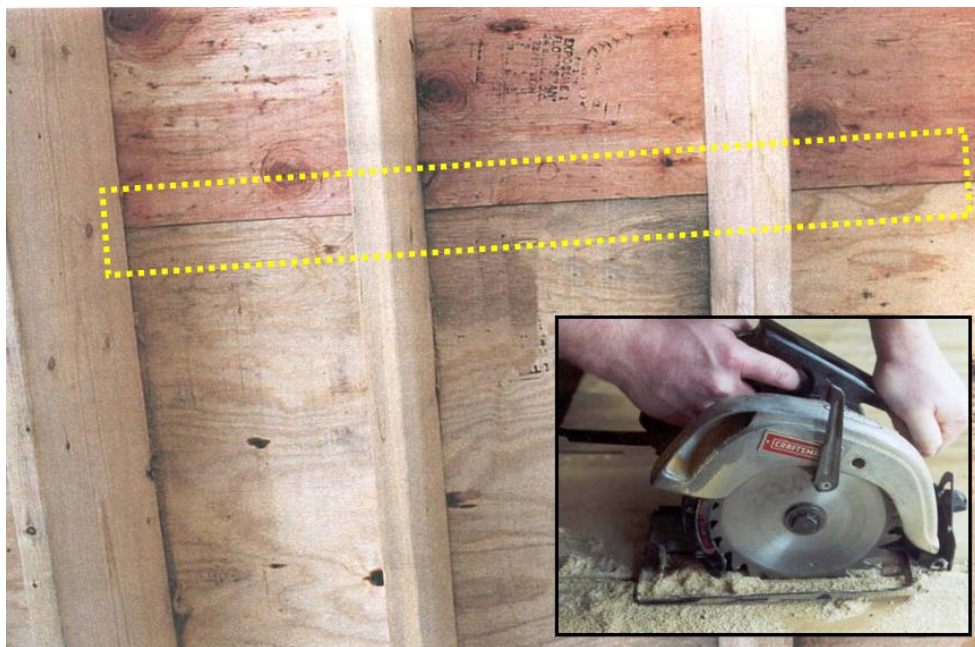
**Figure 4.**  
Inadequate spacing between the adjoining panels; adding space between the panels by cutting a kerf at the panel joints with circular saw (photo insert).

Panels that buckle, warp or twist after installation are usually not defective and typically do not need to be replaced. If the panels were installed too tight (i.e., without the recommended 1/8-inch space at panel ends and edges), spacing can be added by cutting a kerf at the panel joints with a circular saw (see Figure 4). These panels can generally be brought back into plane by securely attaching the deformed portion of the panel to dimension lumber blocking and attaching the blocking to adjacent structural framing members (see Figure 5). Before the panels can be repaired, the root cause of the deformation must be determined and fixed. Additional ventilation or proper ventilation may be needed. Care must be taken not to cut too deep and cause damage to the support framing.

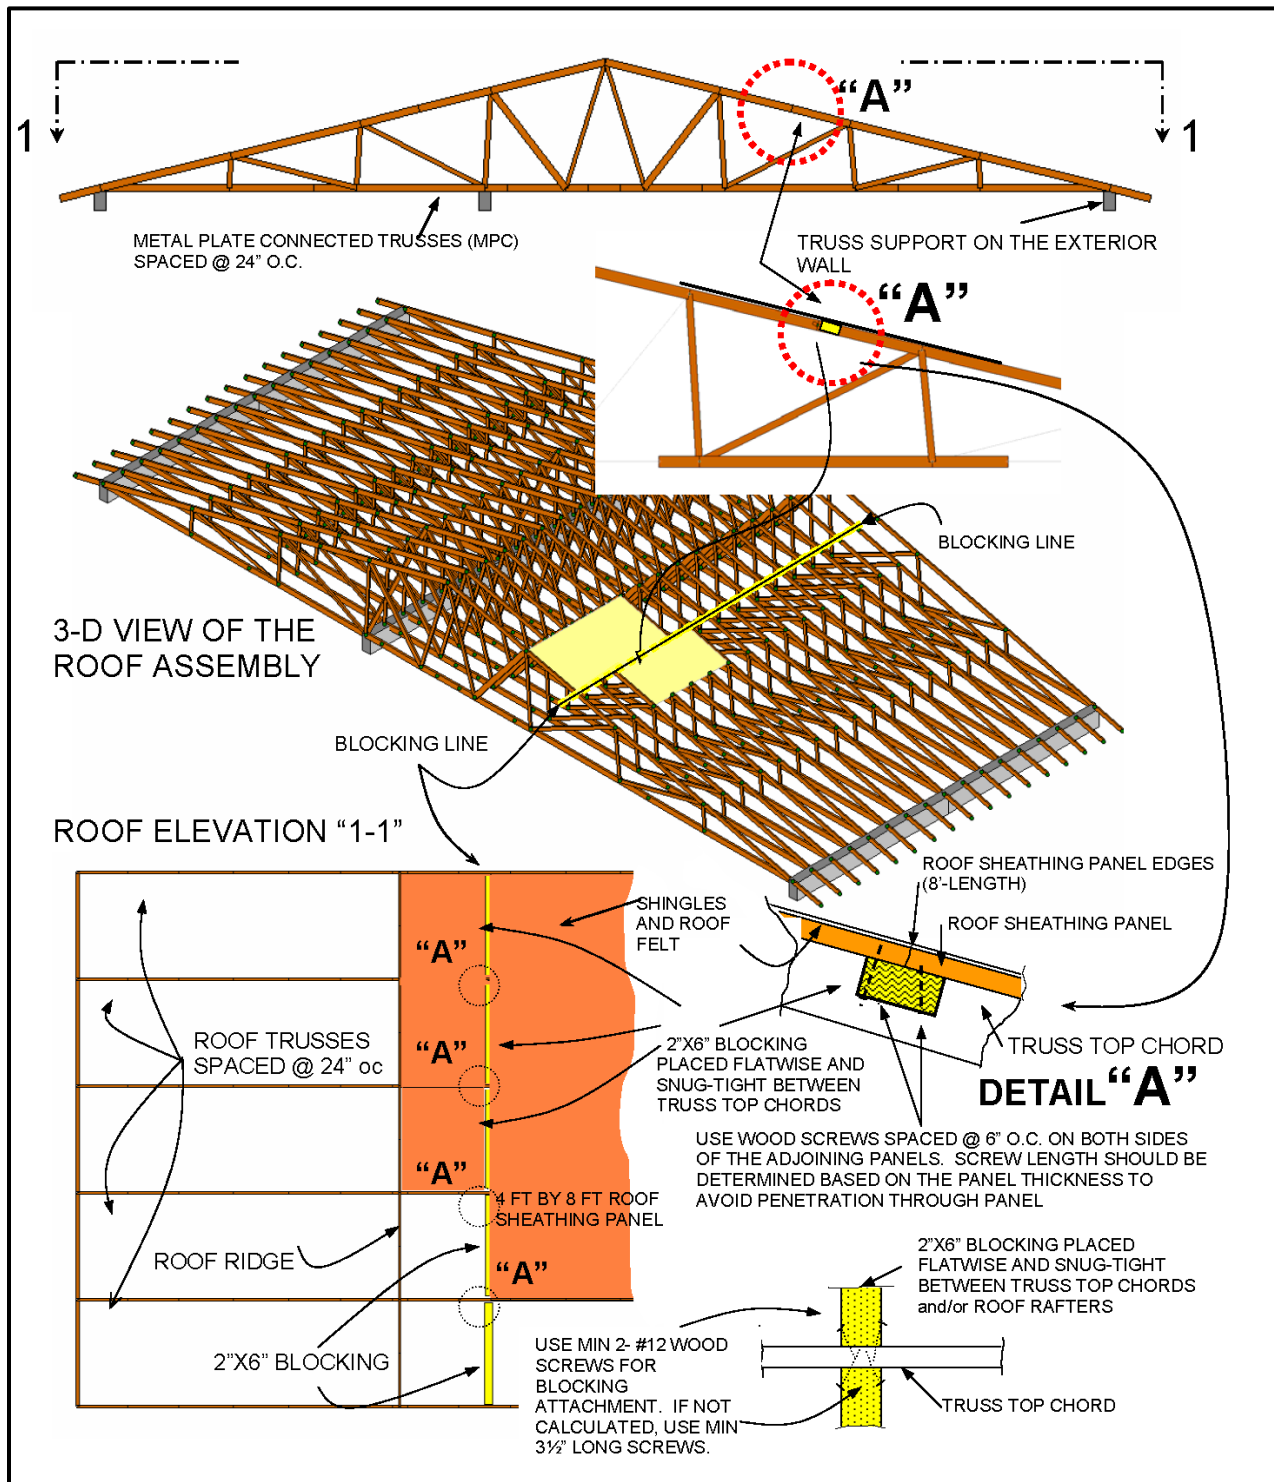
**Figure 6.**  
Repair recommendation for the unsupported and buckled roof sheathing panels.

An example (see Figure 6) of repair recommendation for the unsupported and buckled roof sheathing panels is presented in the drawing on the final page.
